NACIMIENTO WATER PROJECT

Vegetation Replacement/Restoration Plan

November 2006

San Luis Obispo County Flood Control & Water Conservation District

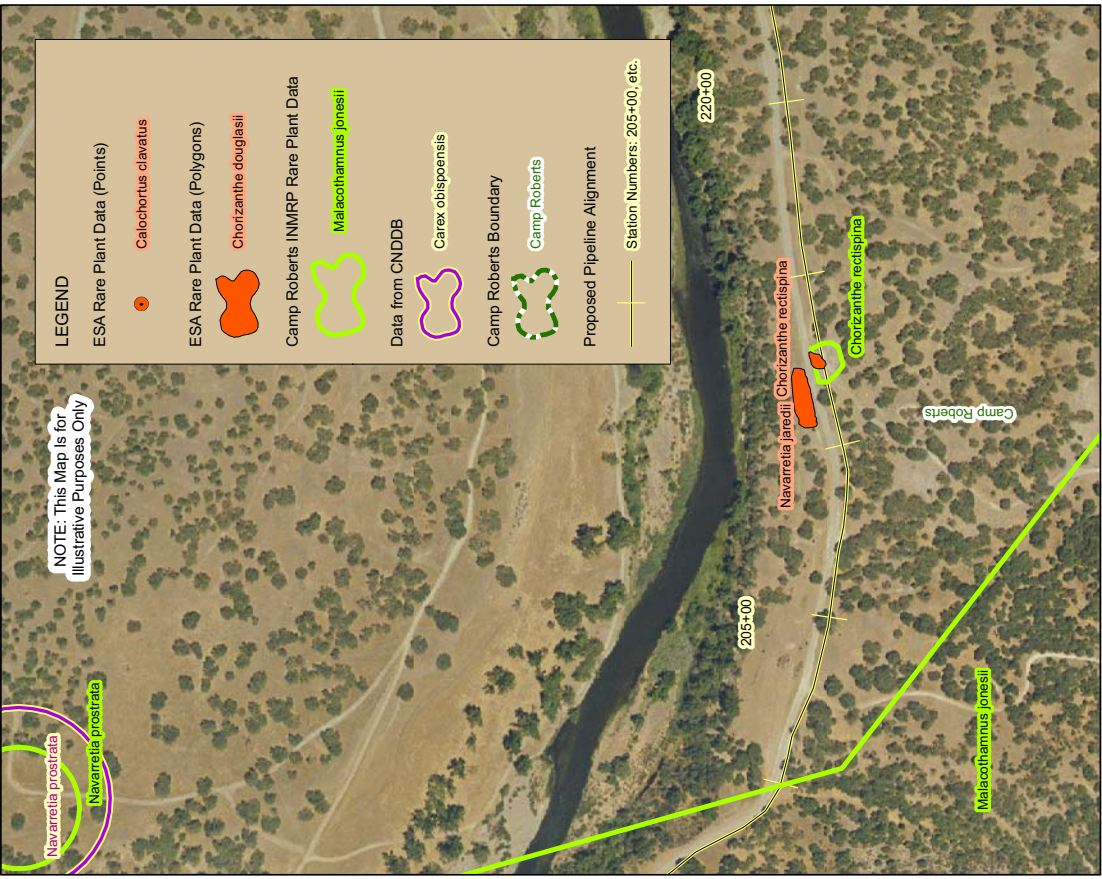
NACIMIENTO WATER PROJECT . 204453
Figure S-04
 Rare Plant Survey Details, Southern Portion

SOURCE: Plant Locations: ESA 2005 and CNDDDB 2005
 Pipeline Alignment: Carollo Engineers, 2003
 Aerial Photos: San Luis Obispo County, 2004
